TOWN OF CARSTAIRS

DEER RIDGE SUBDIVISION – CONCEPTUAL SCHEME

September 10, 2021

Project # 553-01

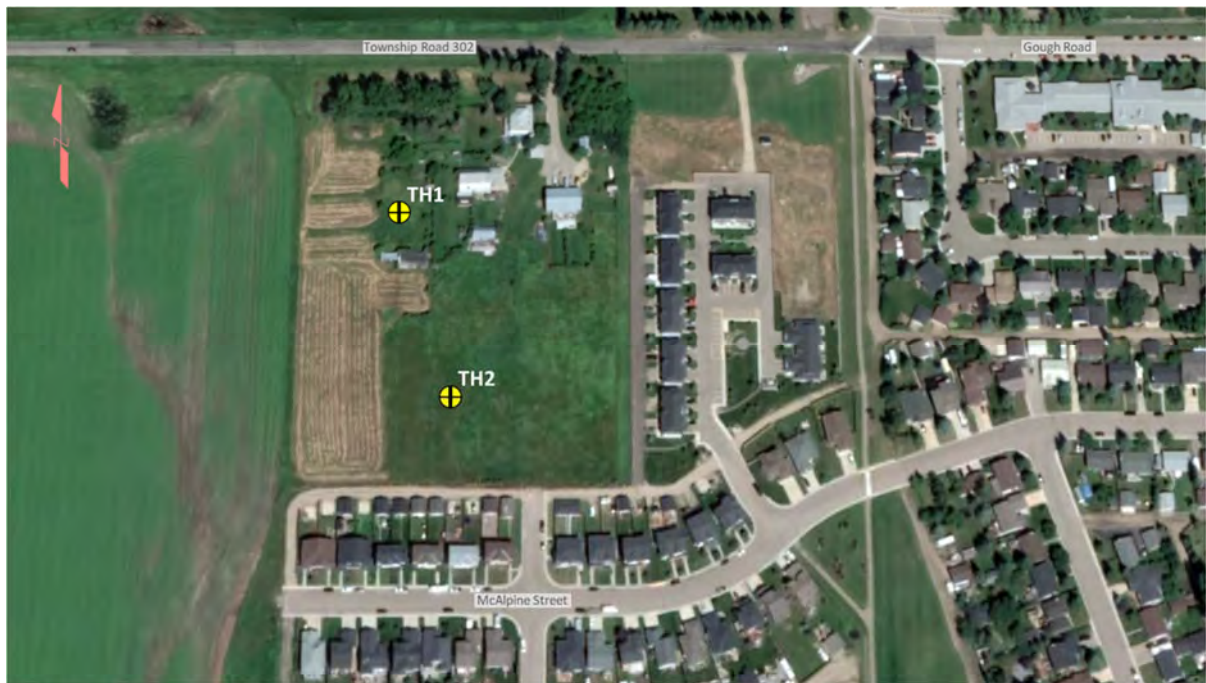
Figure 2: Geotechnical Test Holes Locations

Almor Testing Services Ltd. has completed a geotechnical site investigation that can be found in Appendix C. Two test holes were drilled on June 23, 2021 and are used as the basis for the geotechnical report. Figure 2 shows the location of the test holes on the existing site.

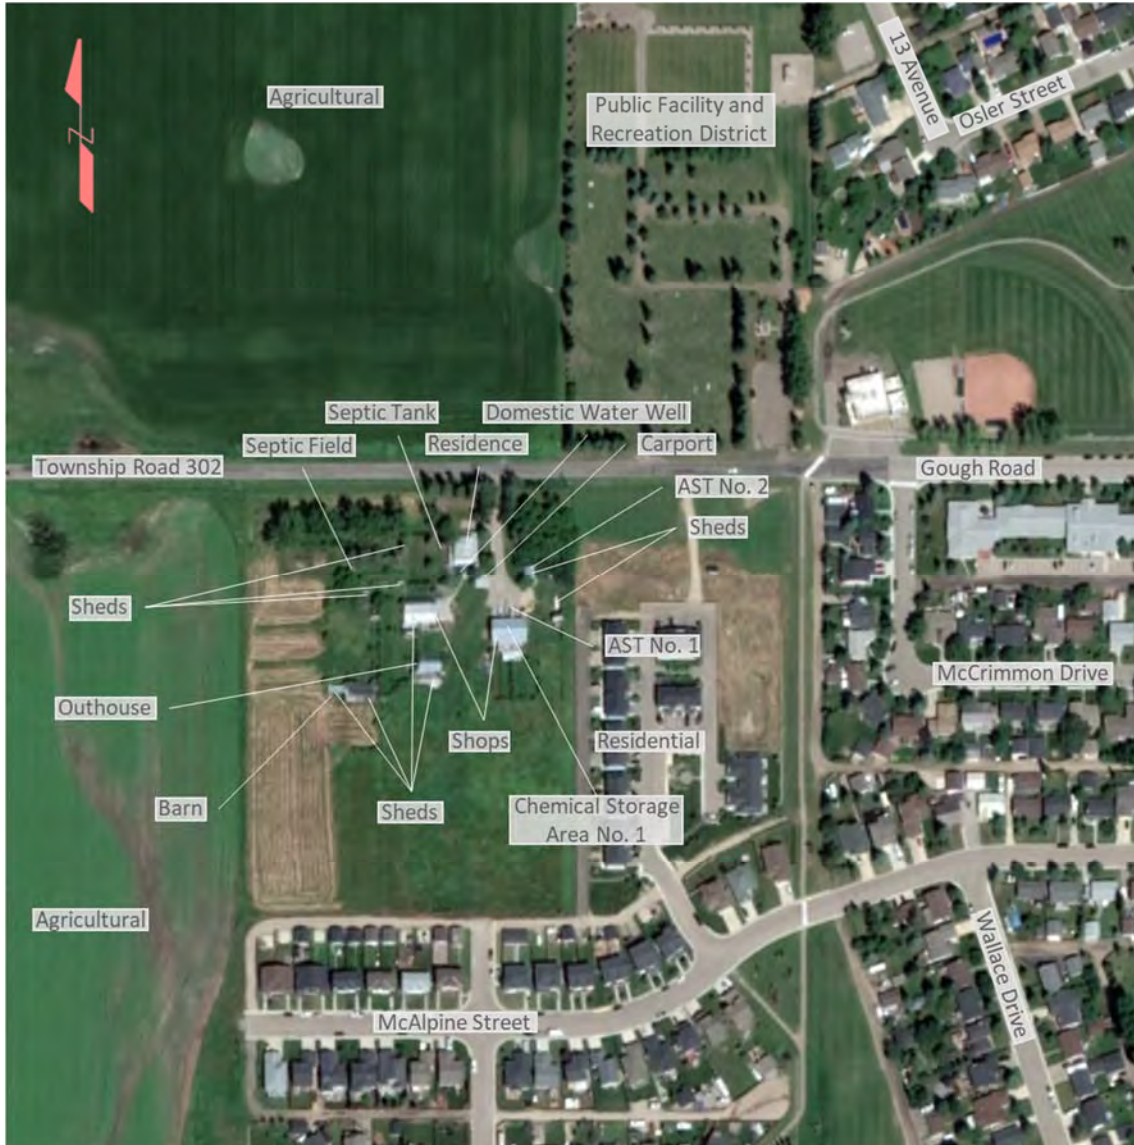
Figure 3: Environmental Site Assessment Site Plan

Figure 3 shows the location of all features identified in the investigation. The Phase 1 ESA determined that no further investigation or assessment of the site is required.

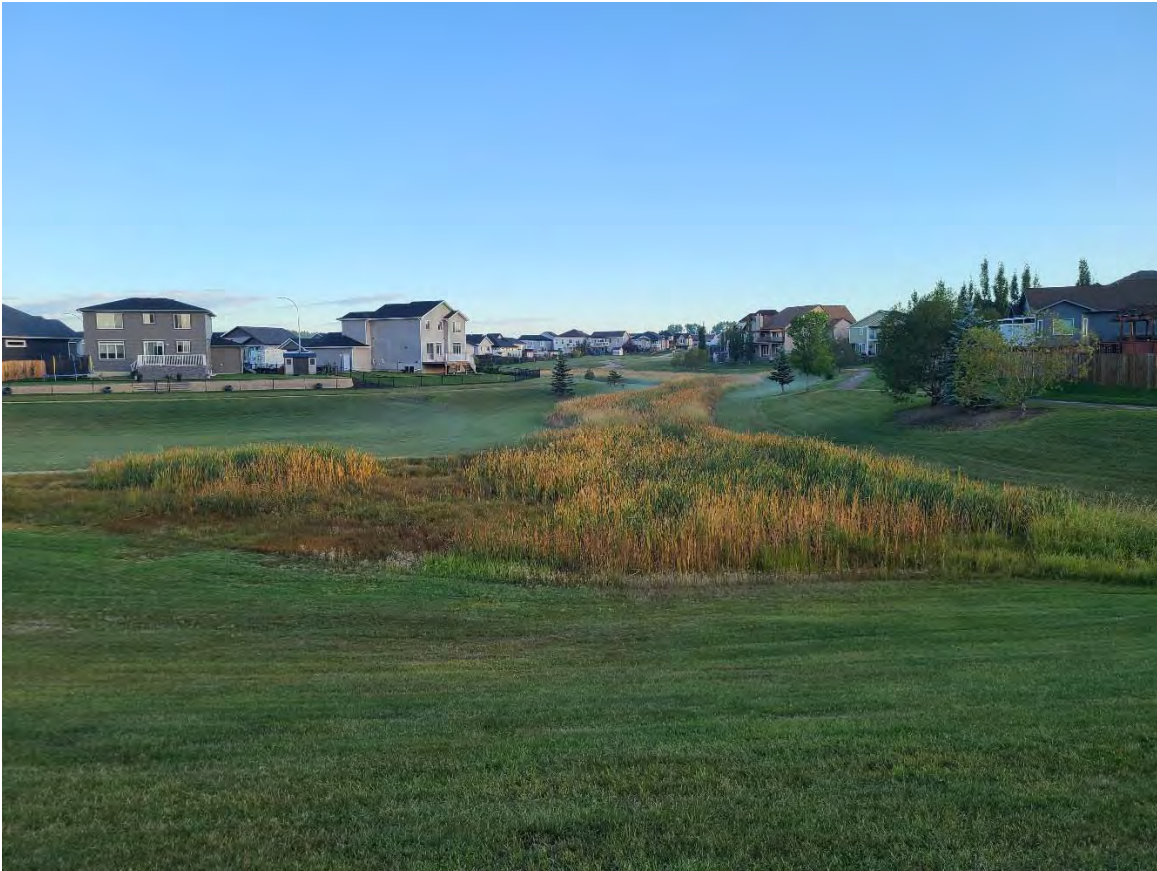
Existing Stormwater Detention Facility

The West Highlands storm water detention facility is existing and is located approximately 300m south of the proposed development. The West Highlands Concept Plan states that the storm water facility was designed to conform to Alberta Environment standards and was sized to manage runoff from the entire West Highlands development and also included the proposed Deer Ridge development as well as some lands to the north of Gough Road.

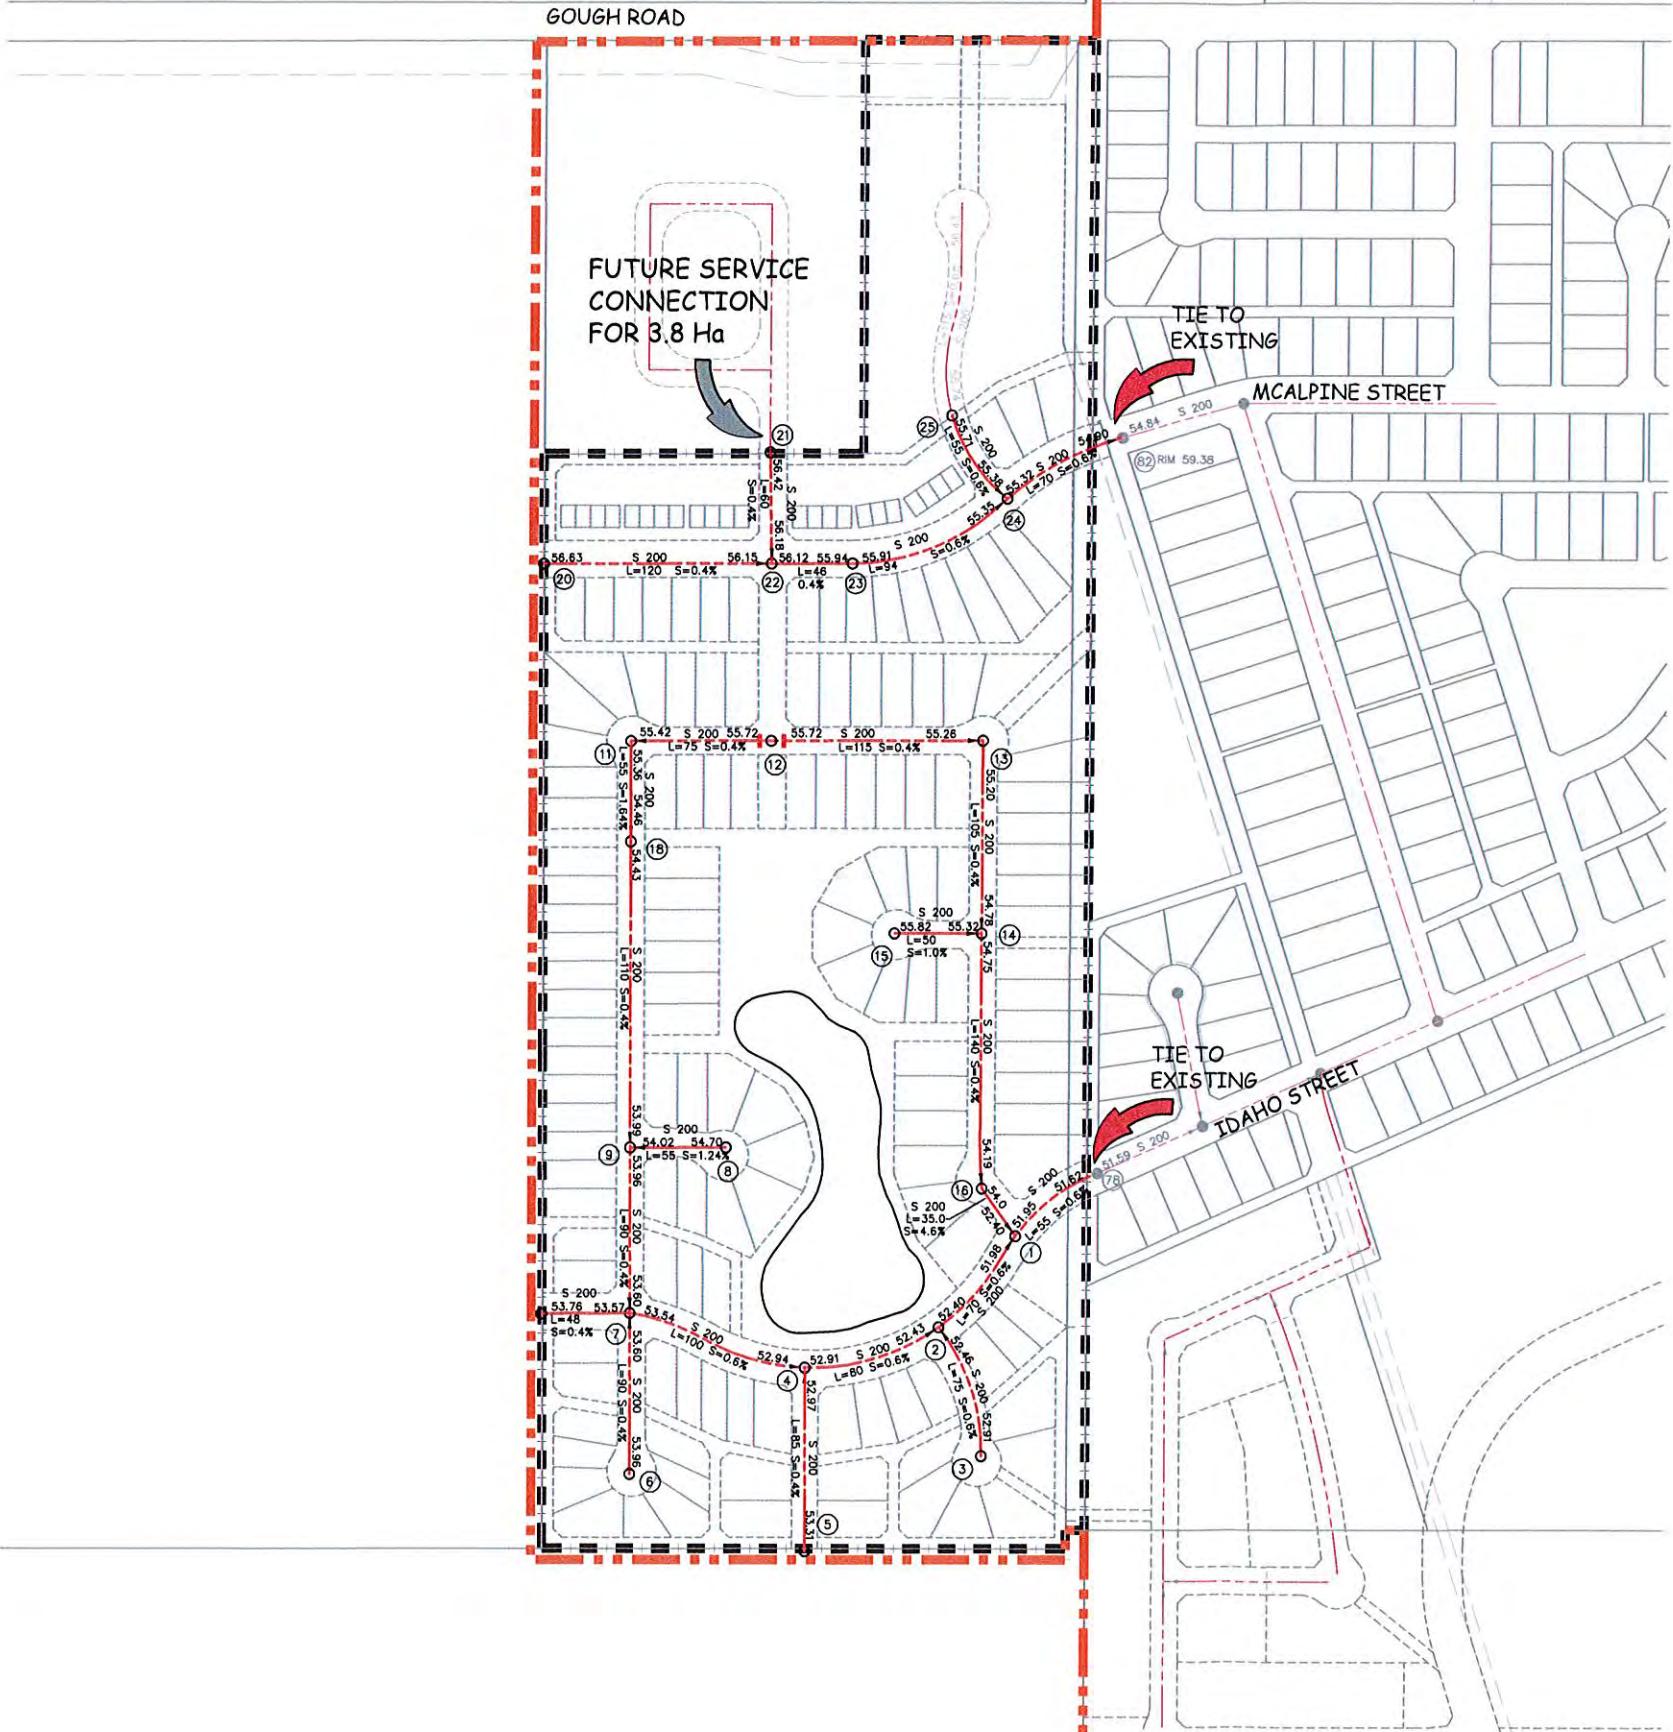
WASTEWATER SERVICING PLAN

- DEVELOPMENT BOUNDARY
- TOWN BOUNDARY
- PROPOSED MAIN
- PROPOSED MANHOLE
- PROPOSED PLUG
- FLOW DIRECTION
- EXISTING MAIN
- EXISTING MANHOLE
- EXISTING PLUG
- TIE TO EXISTING CONNECTION
- FUTURE SERVICE CONNECTION
- MANHOLE REFERENCE NUMBER

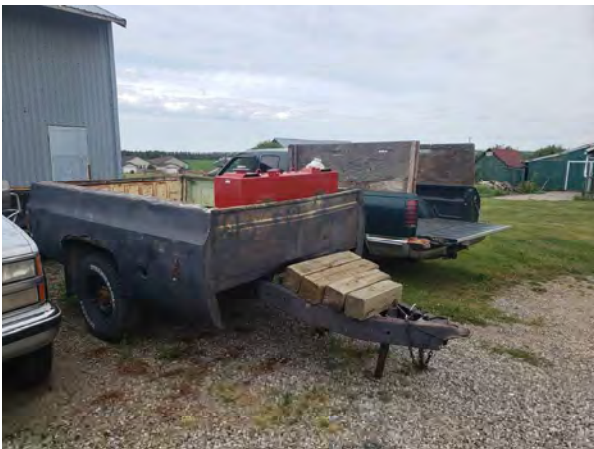
Photo 3: View of AST No. 1 (slip tank) inside a trailer (June 23, 2021).

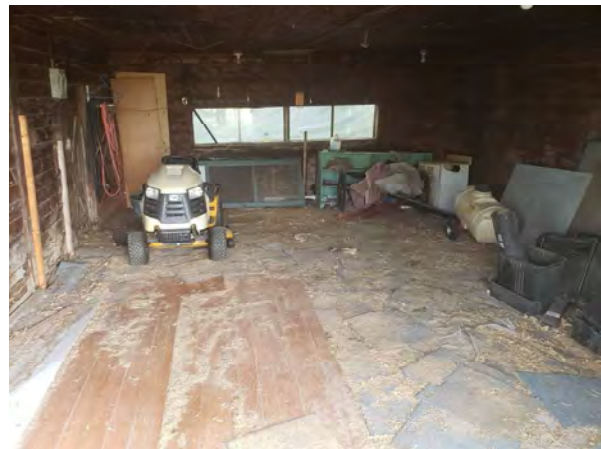
Photo 4: Interior view of the shed east of the residence with AST No. 2 (plastic herbicide tank) and minor staining visible (June 23, 2021).

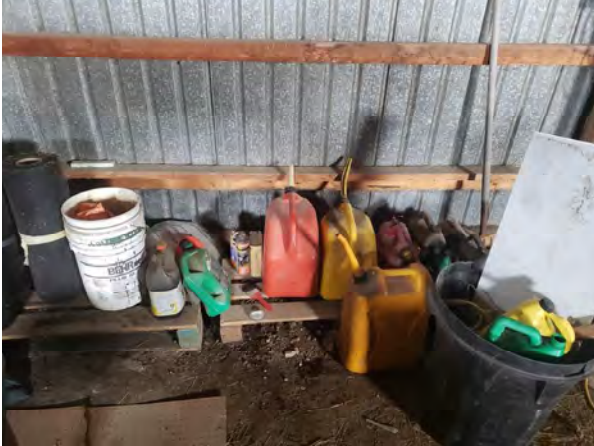
Photo 5: View of Chemical Storage Area No. 1 along the north wall inside one of the shops (June 23, 2021).

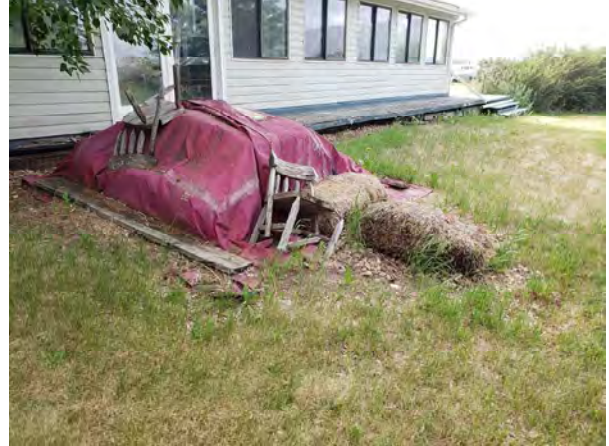
Photo 6: View of the covered septic tank on the west side of the residence (June 23, 2021).

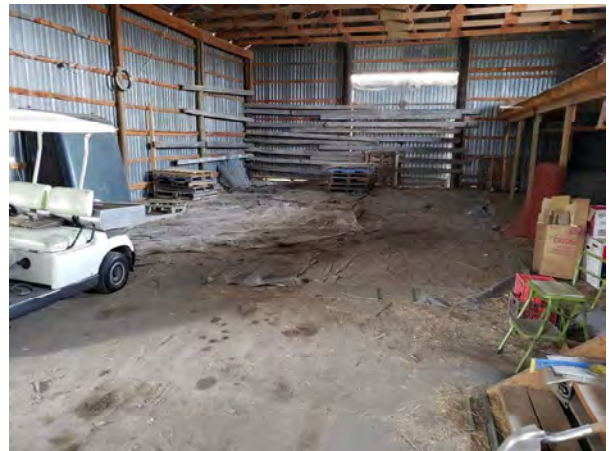
Photo 8: Interior view of one of the shops with minor staining visible (June 23, 2021).
